Technical Service Bulletin

NUMBER: 08-032-00 REV. A

"Service 4WD" Lamp Illuminated On 4X2 Vehicles

2001	(AN)	Dakota
2001	(DN)	Durango

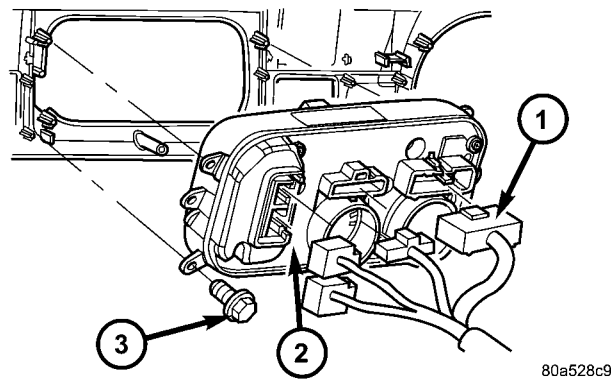
Fig. 4 HVAC CONTROL

The "Service 4WD" lamp is illuminated even though the truck is not a 4X4 vehicle.

12. Remove the cluster bezel from the instrument panel.
13. Remove the four screws that secure the HVAC control to the cluster bezel (Fig. 4).

14. Remove the HVAC control from the instrument panel.
15. Position the new HVAC control (see Parts Required section) in the cluster bezel and secure it with four screws. Tighten the screws to 2.2 N·m (17 ±3 in. lbs.)
