TECHNICAL SERVICE BULLETIN

SUBJECT:
Engine Buck, Surge Or
Noise - Oil Pump Drive
Gear Wear

NO.: 18-08-93 Rev. A
GROUP: Driveability
DATE: Nov. 26, 1993

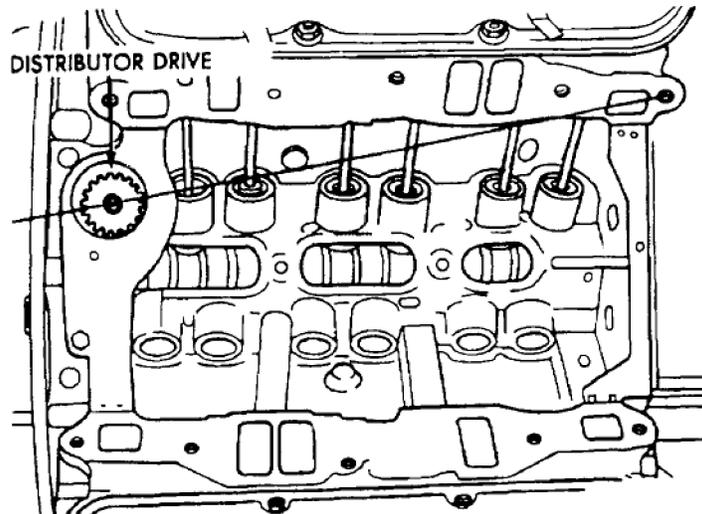
****NOTE:** THE CORRECT POSITION FOR THE DISTRIBUTOR/OIL PUMP DRIVE GEAR BUSHING IS SHOWN BELOW.**

2. Install new drive gear block bushing P/N 01737725 and revised oil pump drive gear P/N 53020546 as outlined in the appropriate service manual.
