LAKEWOOD BELLHOUSING Alignment Procedure

INSTRUCTIONS

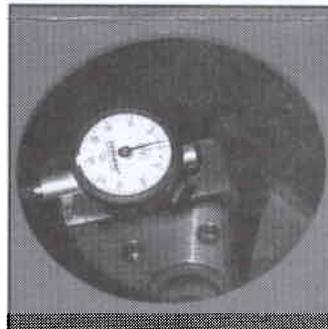
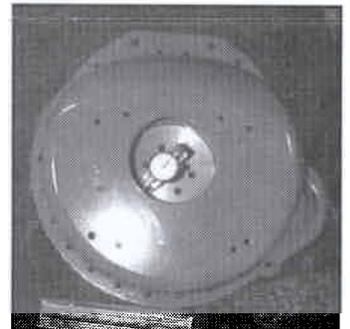
WELD-ON DOWEL LOCATING KIT

Designed for use on race cars that are frequently disassembled, this kit eliminates the need to "dial-in" the bellhousing after each removal. For Ford or Mopar vehicles with .500" dowel holes use #15980. For GM vehicles with .622" dowel holes use #15981. Welding is required.
