Sometimes, due to a variety of reasons, a stock Mopar or Mopar Performance distributor has the rotor out of position enough to cause the spark to jump to the wrong tower. Since there wasn't any easy way to adjust the rotor phasing in the distributor, we created this part. This reluctor has been CNC machined so that you can advance or retard the position of the rotor in relationship to the distributor cap. This will allow you to have the rotor pointed directly at the tower when the spark plug fires. There is no other way to adjust the rotor phasing in Mopar distributors.

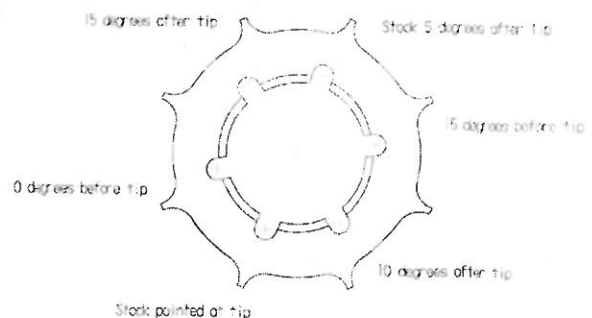
This reluctor has been modified with an additional 4 keyway slots. These slots are positioned at both 10 and 15 degrees before and after the reluctor tips. This will allow you to adjust the position of the rotor in reference to the distributor cap in order to correct any phasing problems that might exist.

The new reluctor has several slots to allow a wide range of phasing adjustment. Be sure to reset the timing when the new reluctor is installed or repositioned. The surest way to set timing is at 3,000 RPM, vac disconnected - then just dial the distributor to your preferred full advance setting - typically, 33 to 35 degrees on most Mopar V8s.

BB Mopars should use one of the slots machined before a tip. Either the 10 or the 15 degree *before* tip slot typically works well with the BB distributor which is rotating counter-clockwise.

SB Mopar distributors rotate clockwise and they should use one of the slots machined *after* a tip. There are either 5, 10 or 15 degrees after the tip slots from which to choose from. Sometimes trial and error is the quickest way to get the job done!
